## COMBINATION AIR VALVE BARAK PVDF , MODEL D-040 2" PVDF

### GENERAL INSTRUCTIONS

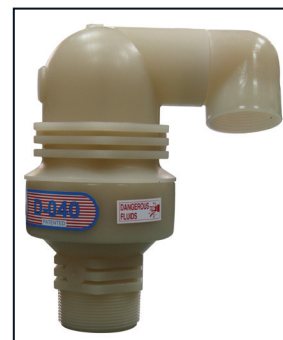
1. Close the service valve under the valve base before servicing.
2. Turn the valve body (1) counterclockwise, release and remove.
3. Remove the clamping stem (4) from inside the valve body (1) and carefully pull out the float (5) with the attached rolling seal (3).

4. Check the soundness of the rolling seal (3) by washing it with water and examining it. Note: Replace the rolling seal (3) in case it is torn.
5. Wash the body (1) and the float (5) with clean water and examine for damage. Note: Replace the float (5) if it is damaged.

6. Clean the drainage elbow (2) to remove insects and debris.
7. Return the float (5) with the attached rolling seal (3) to its original position in the valve body (1) and lock them into place with the clamping stem (4).

8. Return the valve body (1) to the base (7) and close by turning it clockwise. Note: First make sure the O-ring (6) is seated properly in the base of the valve (7).
